NEW ZEALAND FIRE SERVICE

Operational Review Report

**Structure fire with damage
F163587**

**8B Kahika Rd,
North Shore City**

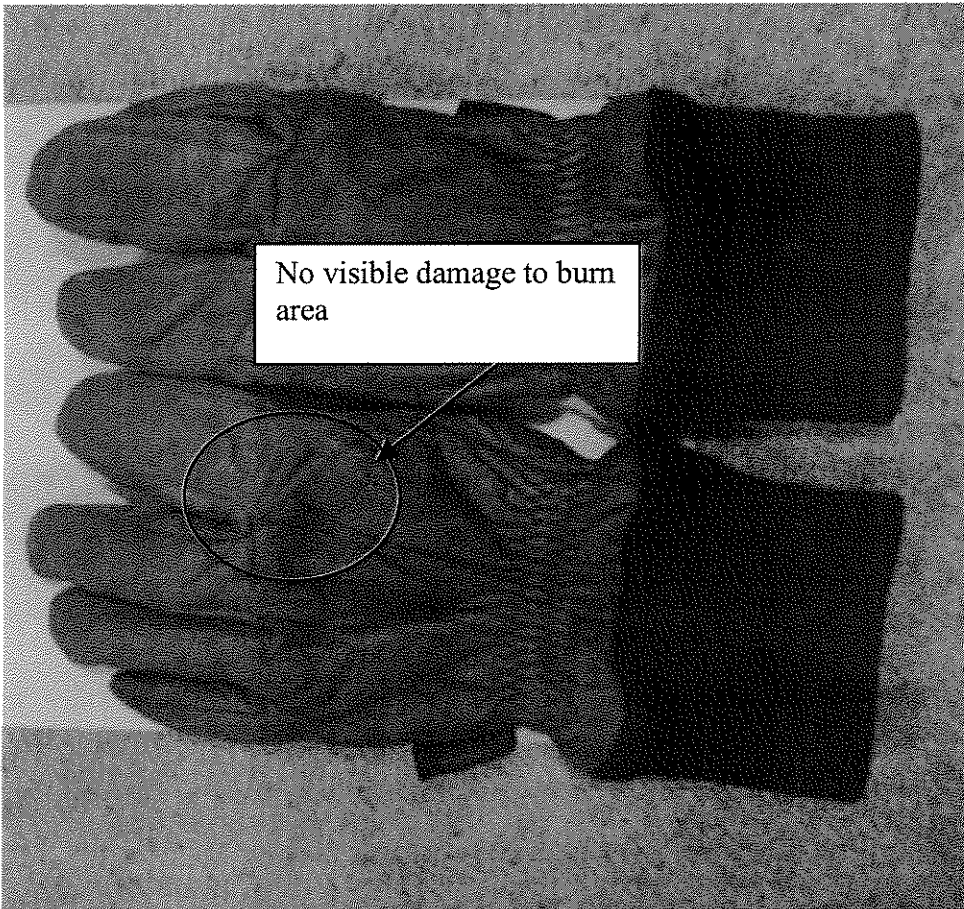
The burns to both the hands of the injured firefighters were situated where their upper most hand had held the branch. As the glove was closed and compressed on the skin the heat was able to radiate through the glove. Likewise the shoulder burn was in the area where the Breathing Apparatus straps had pulled the jacket tight. This meant the air barrier between the protective jacket and the firefighter was removed.

No visible damage to burn area

Training needs to be delivered to re-enforce the importance of exposure times in these heated environments and the importance of the layer between the PPC and the firefighter being maintained. This should be reinforced at the annual BA refresher course when delivered.

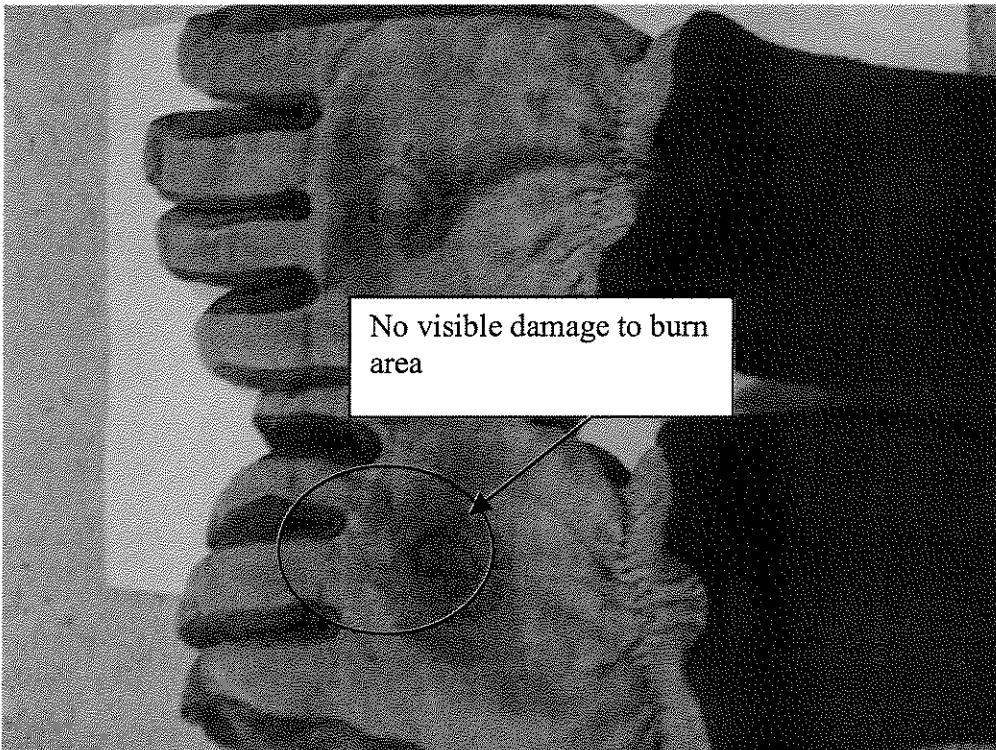
No visible damage to burn area
