# Fire and Emergency NZ

Accident investigation into fatal landslide incident at Muriwai  
on 13 February 2023

Incident Number F3667912

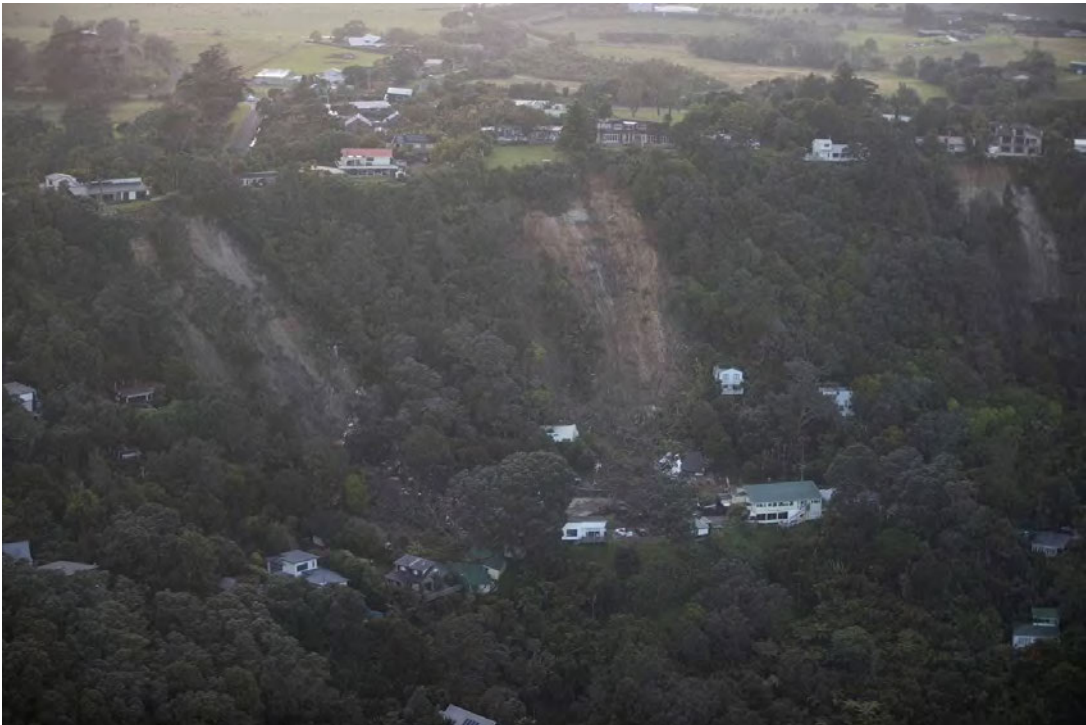
**Figure 1** above. Several slips above Motutara Rd. Firefighter rescue site at bottom of centre slip. Oaia Road houses along top of hill. (NZ Herald)

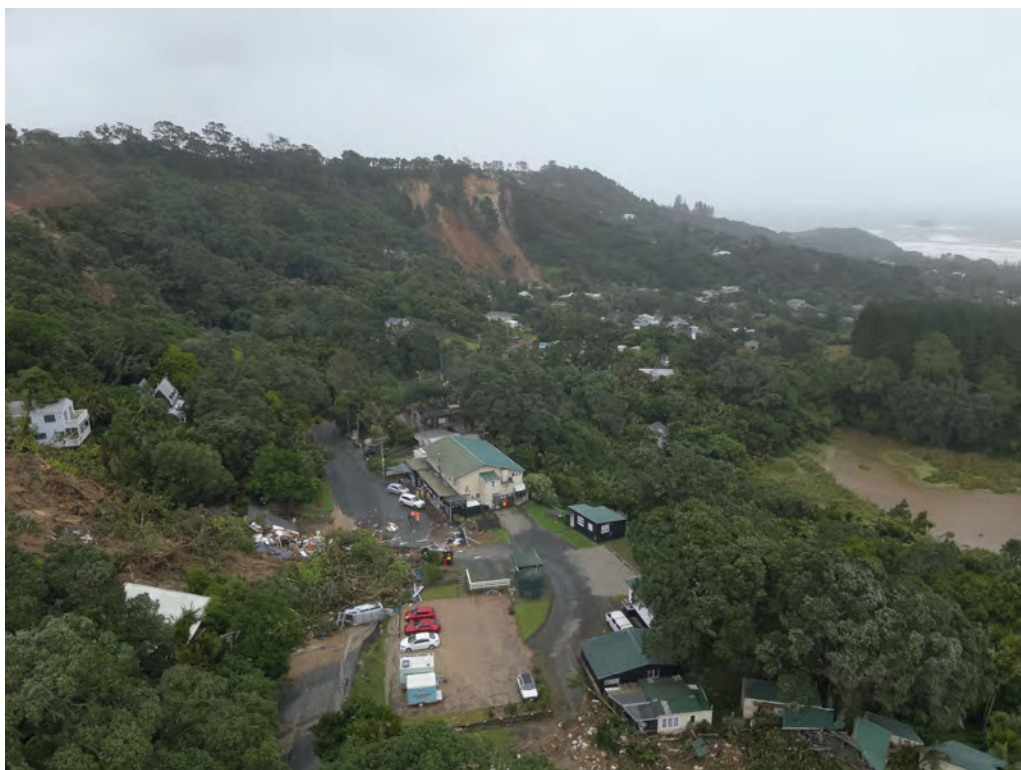
**Figure 2** above. Rescue site in foreground where debris covers road. Lodge café is the large building in the centre past the rescue site. (USAR photo taken 14:00 hrs on 14 Feb)

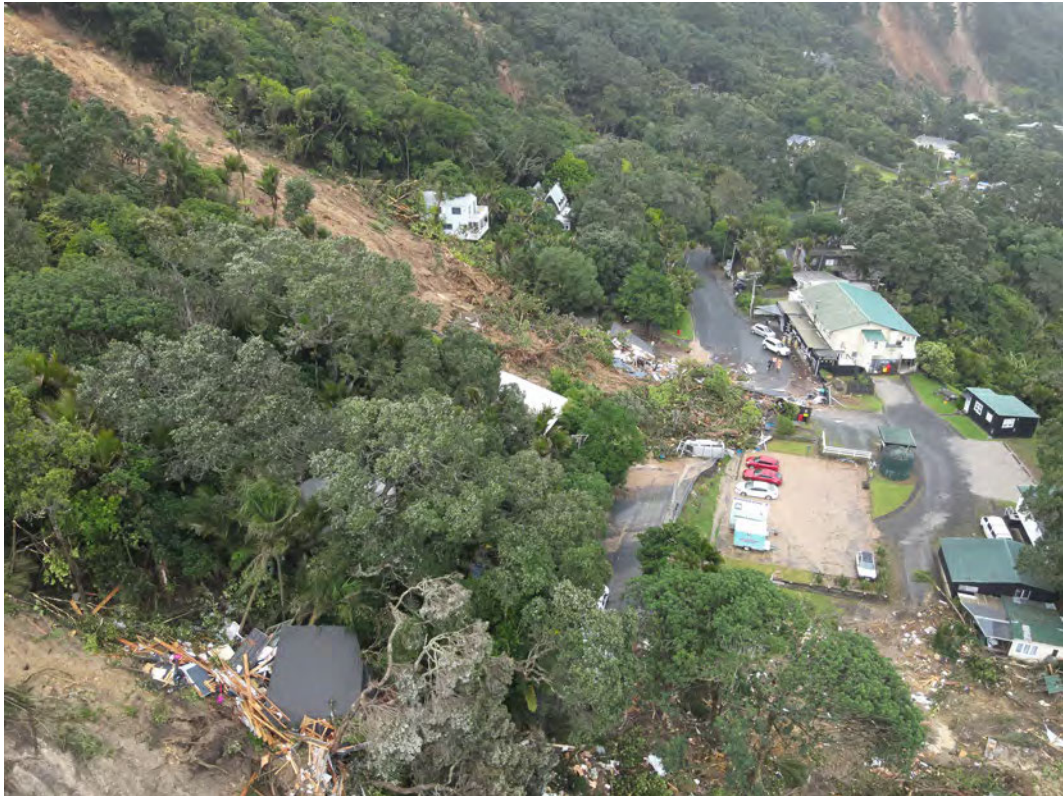
**Figure 3** above. Rescue site in centre right where debris crosses the road. The landslide in foreground happened during the rescue approx. 1 hr 50 mins after the first landslide occurred. (USAR photo taken 14:00 hrs on 14 Feb)

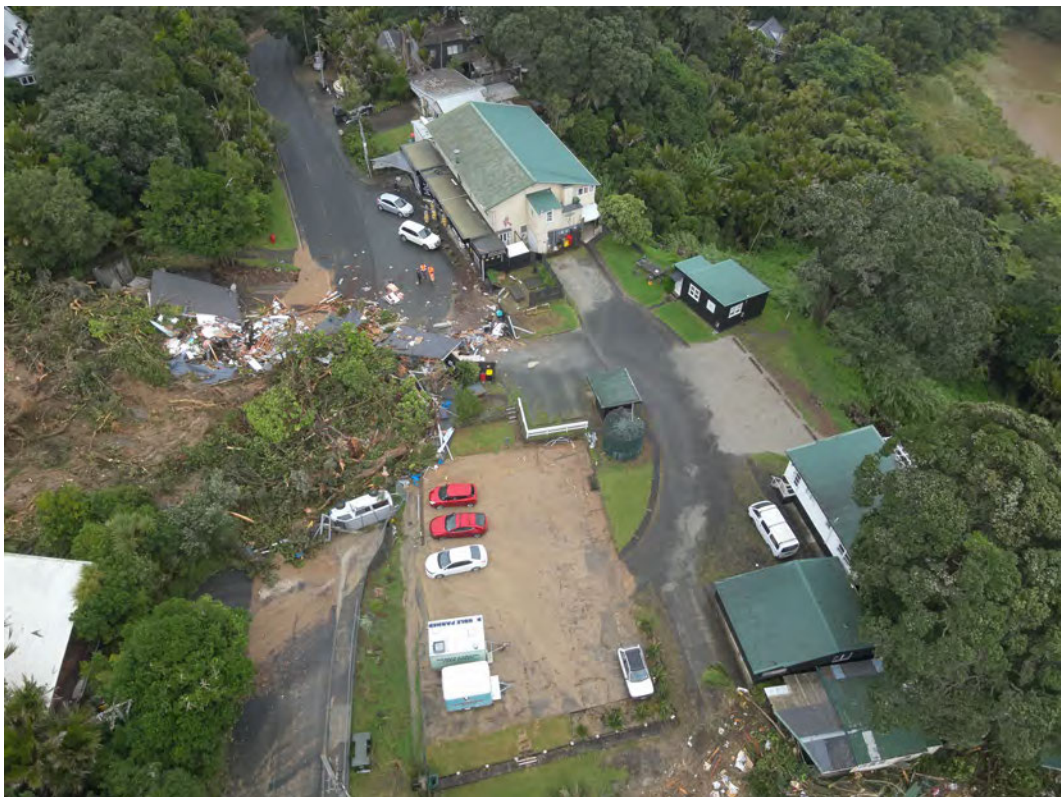
**Figure 4** above. Close up of rescue site on roadway. (USAR photo taken 14:00 hrs on 14 Feb)

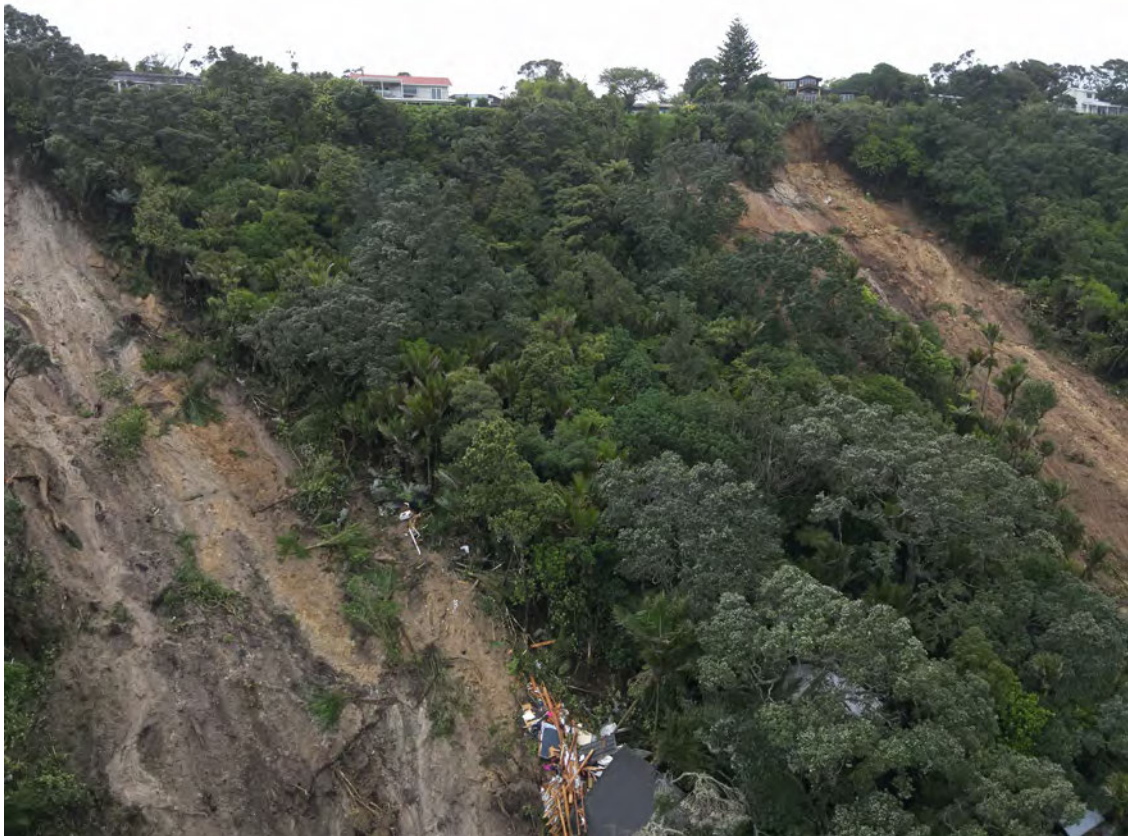
**Figure 5** above. Hillside above Motutara Rd with Oaia Rd houses at top of hill. The far slip is the first slip involving the firefighters with the second slip in foreground. (USAR photo taken 14:00 hrs on 14 Feb)

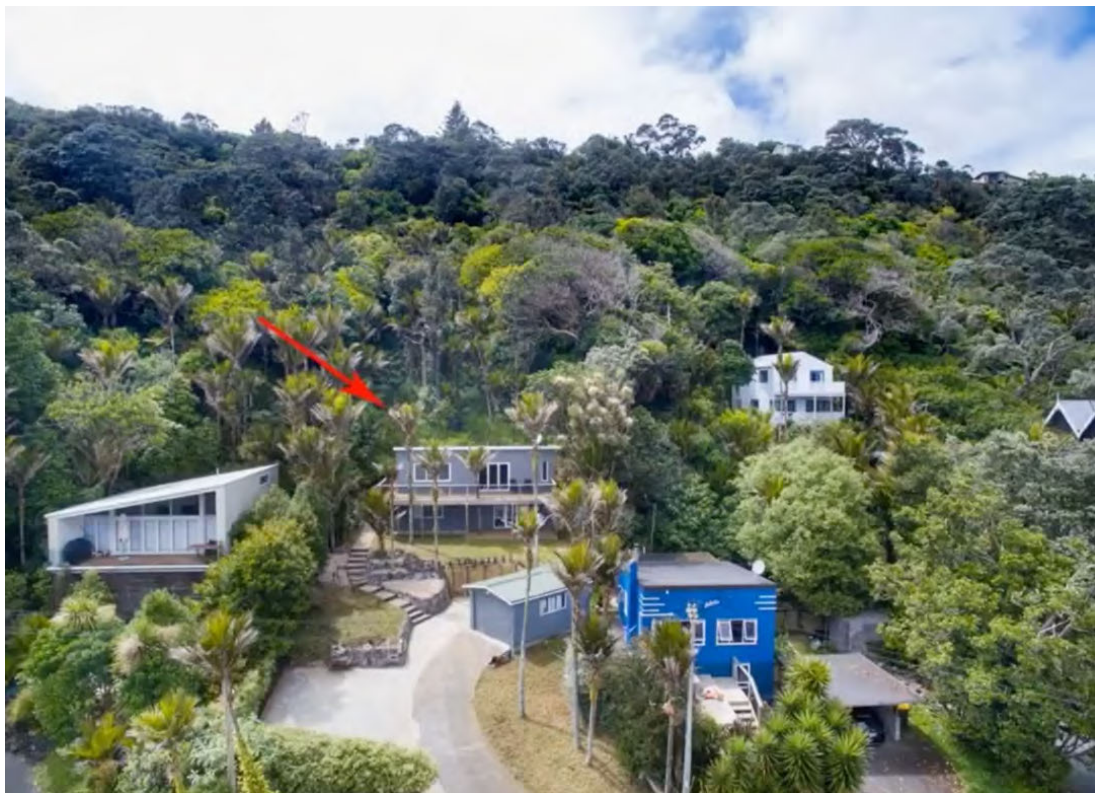
**Figure 6** above. Firefighters were working at the centre house indicated by the arrow before the landslide. (Real estate photo)

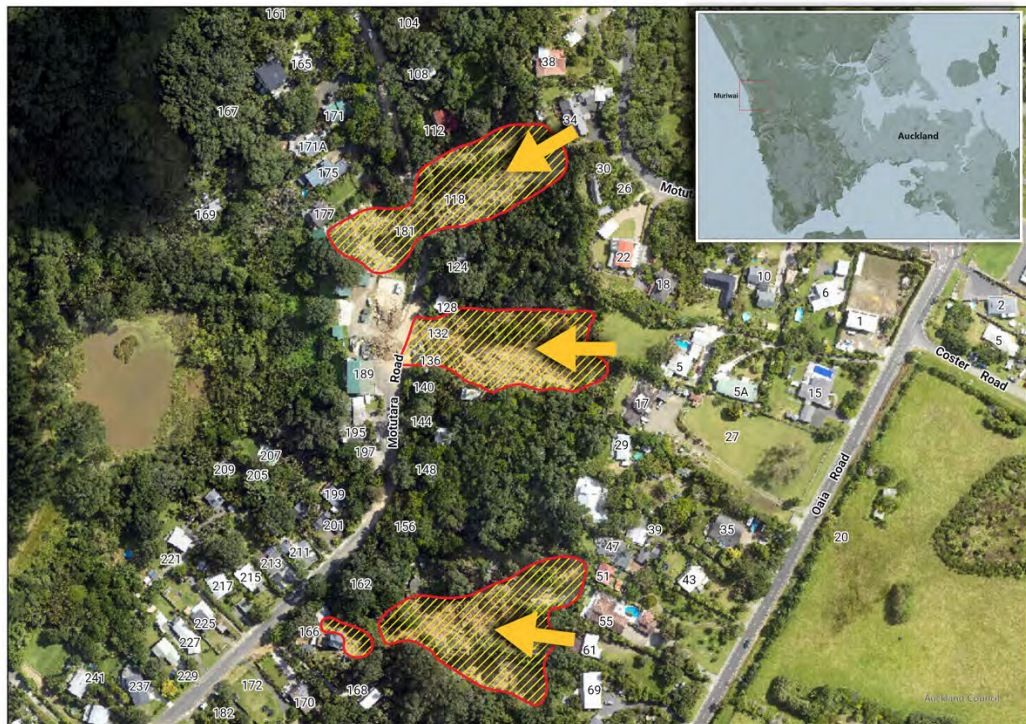
**Figure 9** above. Satellite photo with landslides superimposed. The arrows indicate the direction of the landslides' travel. The rescue operation took place near the left edge of the centre landslide on Motutara Road. The top landslide occurred during the rescue operation approx. 1 hr 50 mins after the centre landslide occurred.

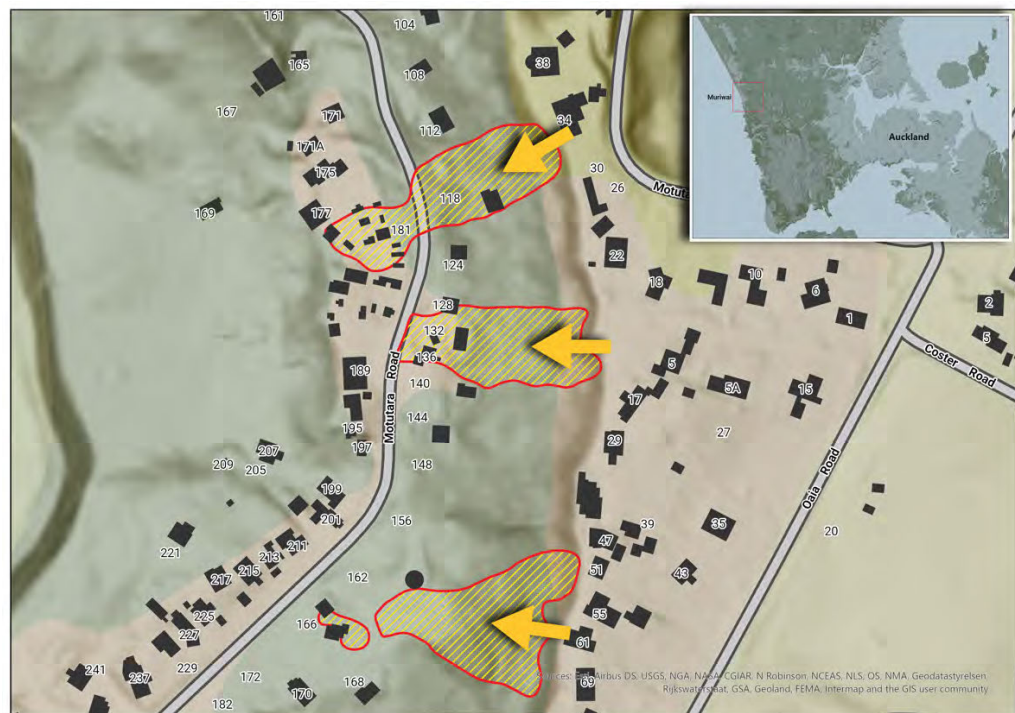
**Figure 10** above. Map showing houses that were destroyed in the path of the landslides.
