NEW ZEALAND FIRE SERVICE

Operational Review Report

**Structure fire with damage
F163587**

**8B Kahika Rd,
North Shore City**

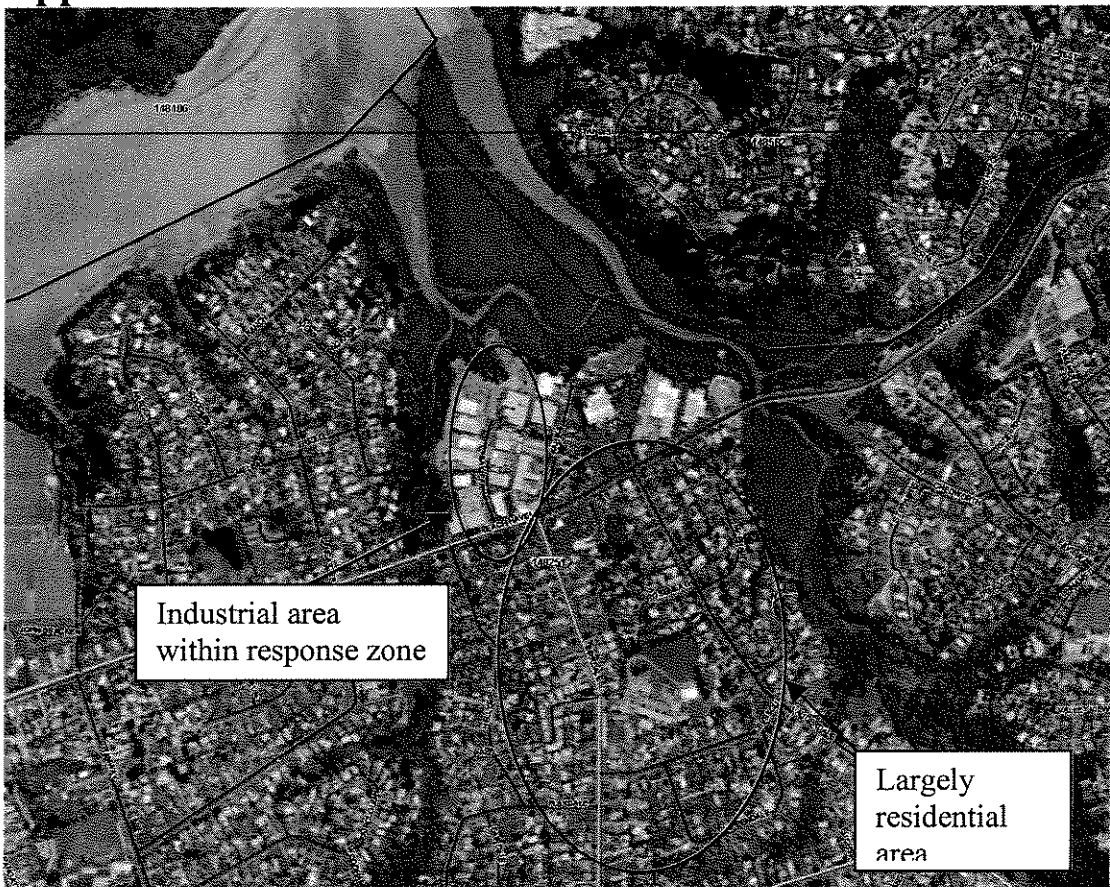
Figure 1

The actions of Comcentre staff during this incident highlighted inaccuracies within our turnout zones. There are areas within some response zones that require specialized response as a result of the risk they pose. This is shown in Appendix A (Figure1) where this response zone is a combination of both industrial and residential. The standard response string to the residential areas is not necessarily the appropriate response to the commercial or industrial areas.
